TEST REPORT

No. : XMCCM151101286

Sample Name : FIRE RATED LED DOWNLIGHT

Test Item : Fire Resistance Test

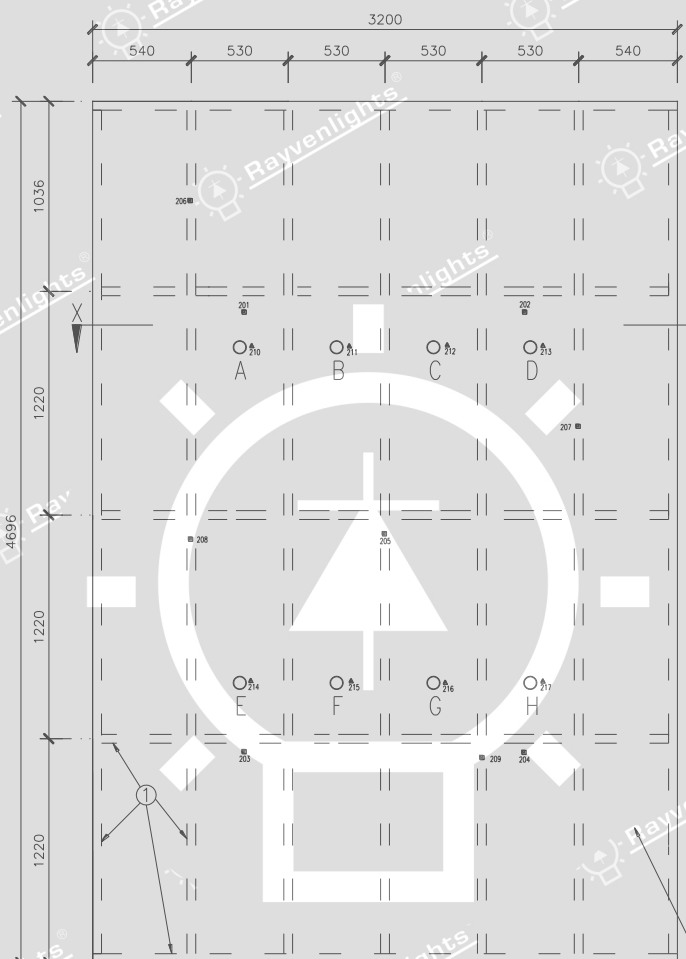
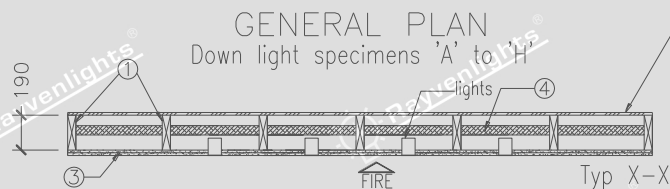
Figure 1 - Specimen General Plan

Positions of thermocouples

- surface mounted thermocouples on upper surface of floorboards
- ▲ mineral insulated (MI) thermocouples at mid-cavity, adjacent to each downlight

Do not scale. All dimensions are in mm.

Thermocouples were provided to monitor the unexposed surface of the floor assembly and the output of all instrumentation was recorded at no less than one minute intervals. The locations and reference numbers of the various unexposed surface and internal thermocouples are shown in Figure 1.

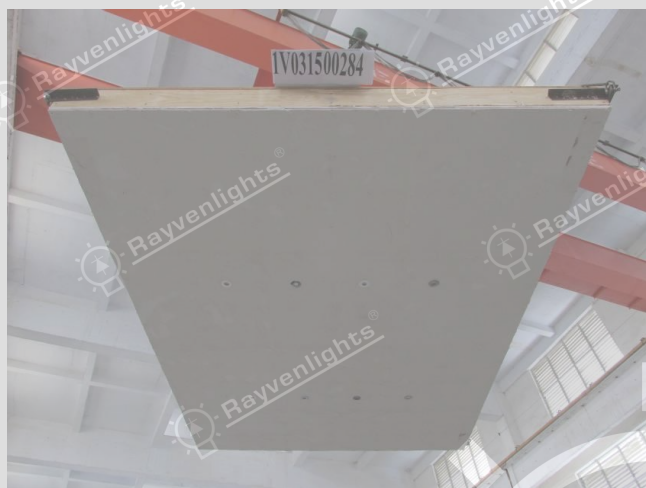
Photo 17: The exposed surface of the specimen before the test.

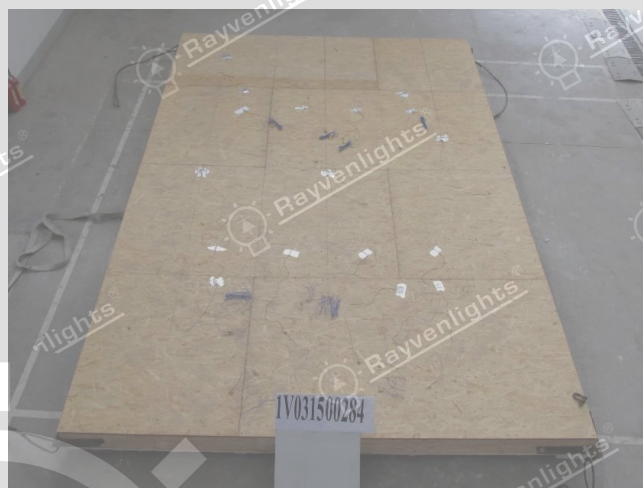
Photo 18: The unexposed surface of the specimen before the test. (Without load).

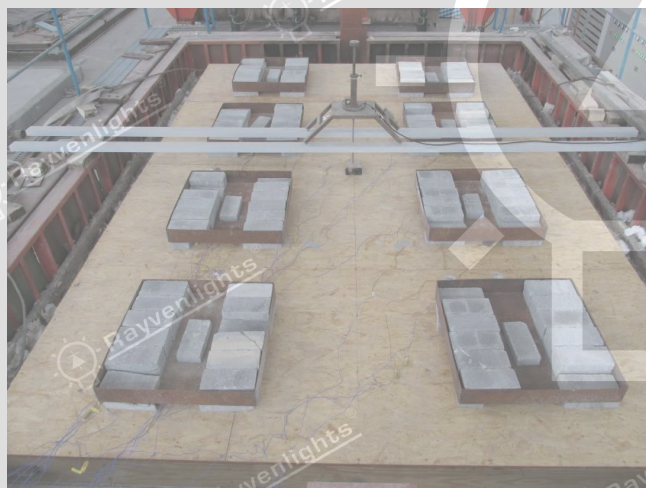
Photo 19: The unexposed surface of the specimen before the test. (Already load).

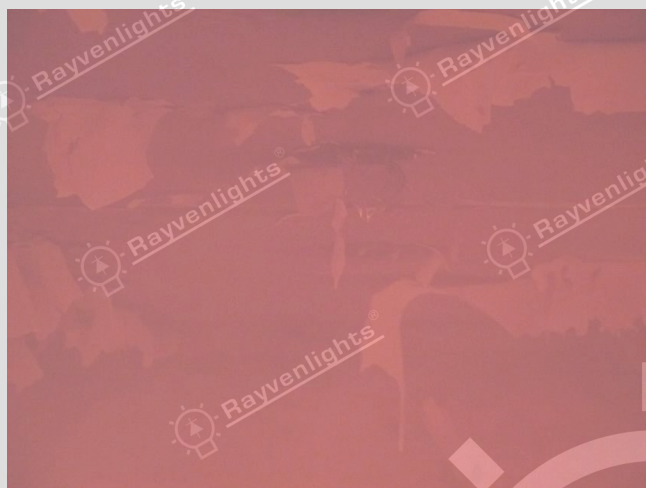
Photo 21: The exposed surface of the specimen after a test duration of 27 minutes, showing the specimen 'G' fused.

Time (min)	Observation (All observations are from the exposed face unless noted otherwise)
0	Test started.
15	Coating of the plasterboard ceiling started to fall away.
25	Specimen 'C' and 'G' fused.
40	The first layer of plasterboard ceiling started to sag slightly and joints began to open.
41	The first layer of plasterboard ceiling sagged seriously.
48	The first layer of plasterboard ceiling nearby specimen 'E' fell away.
58	More first layer of plasterboard ceiling fell away.
65	Lots of smoke release increased inside the furnace, resulting the observation from the exposed side discontinued.
91	Test terminated at sponsor's request.

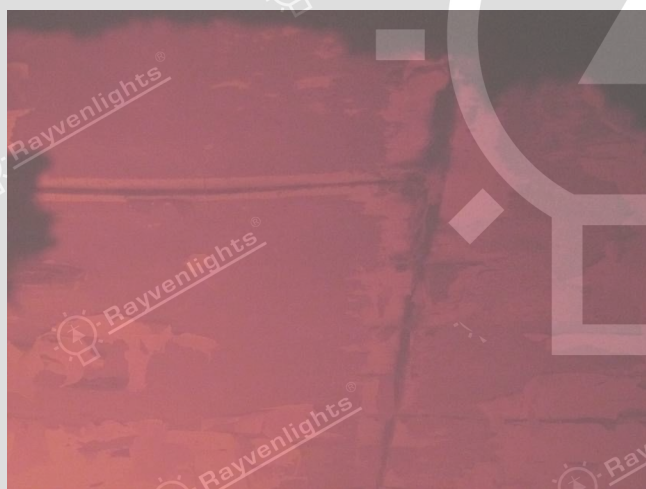
Photo 23: The exposed surface of the specimen after a test duration of 37 minutes, showing the first layer of plasterboard ceiling started to sag and joints began to open.

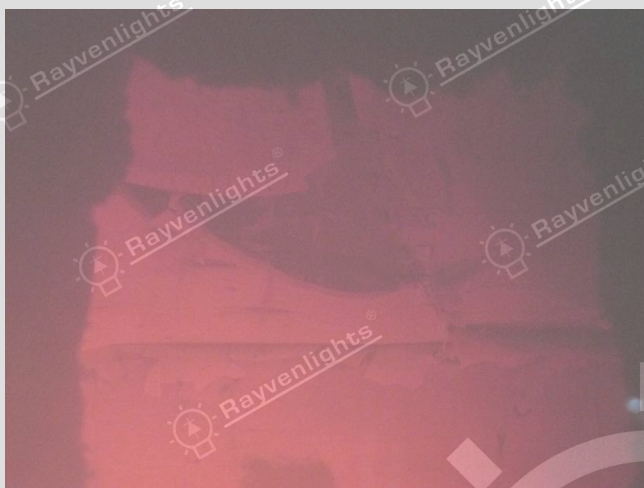
Photo 25: The exposed surface of the specimen after a test duration of 50 minutes, showing the first layer of plasterboard ceiling fell away.
